National Dam Inspection Program.
Upper Donohoe Dam (now Referred to as)
Twin Lakes Number 2 Dam, NDS I.D.
PA-00478), Ohio River Basin, Little
Crestree Creek, Westmoreland County,
Pennsylvania. Phase I Inspection
Report.

PHASE I REPORT
NATIONAL DAM INSPECTION PROGRAM

Upper Donohoe Dam: NDS I.D. No. PA-00478

Owner: Westmoreland County
State Located: Pennsylvania (PennDER I.D. No. 65-55)
County Located: Westmoreland
Stream: Little Crabtree Creek
Inspection Date: 13 December 1978
Inspection Team: GAI Consultants, Inc.
570 Beatty Road
Monroeville, Pennsylvania 15146

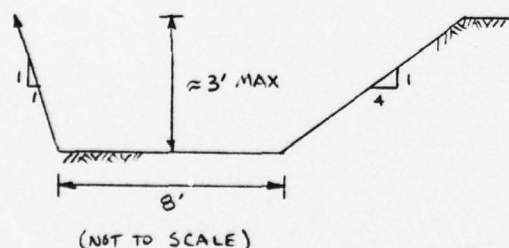
- ALTHOUGH THE HYDROLOGIC/HYDRAULIC EVALUATION OF THIS FACILITY WILL BE PERFORMED ASSUMING THAT THE SPILLWAY CHUTE CHANNEL IS IN IDEAL CONDITION (SEE SECTION 5.3), SOME ESTIMATE OF THE ACTUAL PRESENT SPILLWAY SYSTEM CONSEQUENCES AND CAPACITY SHOULD BE MADE.
- DUE TO THE PRESENCE OF THE BREACH IN THE LEFT CHUTE CHANNEL WALL (CAUSED BY THE PLACEMENT OF A TEMPORARY EARTH AND ROCK ROAD ACROSS THE CHUTE CHANNEL @ ABOUT 35 FT DS FROM THE SPILLWAY CREST), SOME SPILLWAY DISCHARGE WILL FLOW TOWARD THE TOE WHEN THE CHANNEL DEPTH EXCEEDS ABOUT 1.5 FT OR SO.
- THE ACTUAL PRESENT CRITICAL FLOW CONTROL SECTION IS LOCATED ABOUT 70 FT DS FROM THE SPILLWAY (SEE SKETCH ON SHEET 6). THE APPROXIMATE CROSS-SECTION DIMENSIONS ARE GIVEN IN THE SKETCH BELOW. ASSUMING UNIFORM FLOW ABOVE THIS SECTION (REF 7, PG. 5), THE

MAXIMUM DEPTH OF FLOW UPSTREAM FROM THE SECTION WILL BE ≈ 2.7 FT (CORRESPONDING TO THE MAXIMUM SPILLWAY DEPTH PRIOR TO OVERTOPPING W/ THE CRITICAL CONTROL ON THE CREST). ALSO, IGNORING THE POSSIBLE FLOW THROUGH THE LEFT CHUTE CHANNEL WALL BREACH, THE SPILLWAY CAPACITY CAN BE FOUND

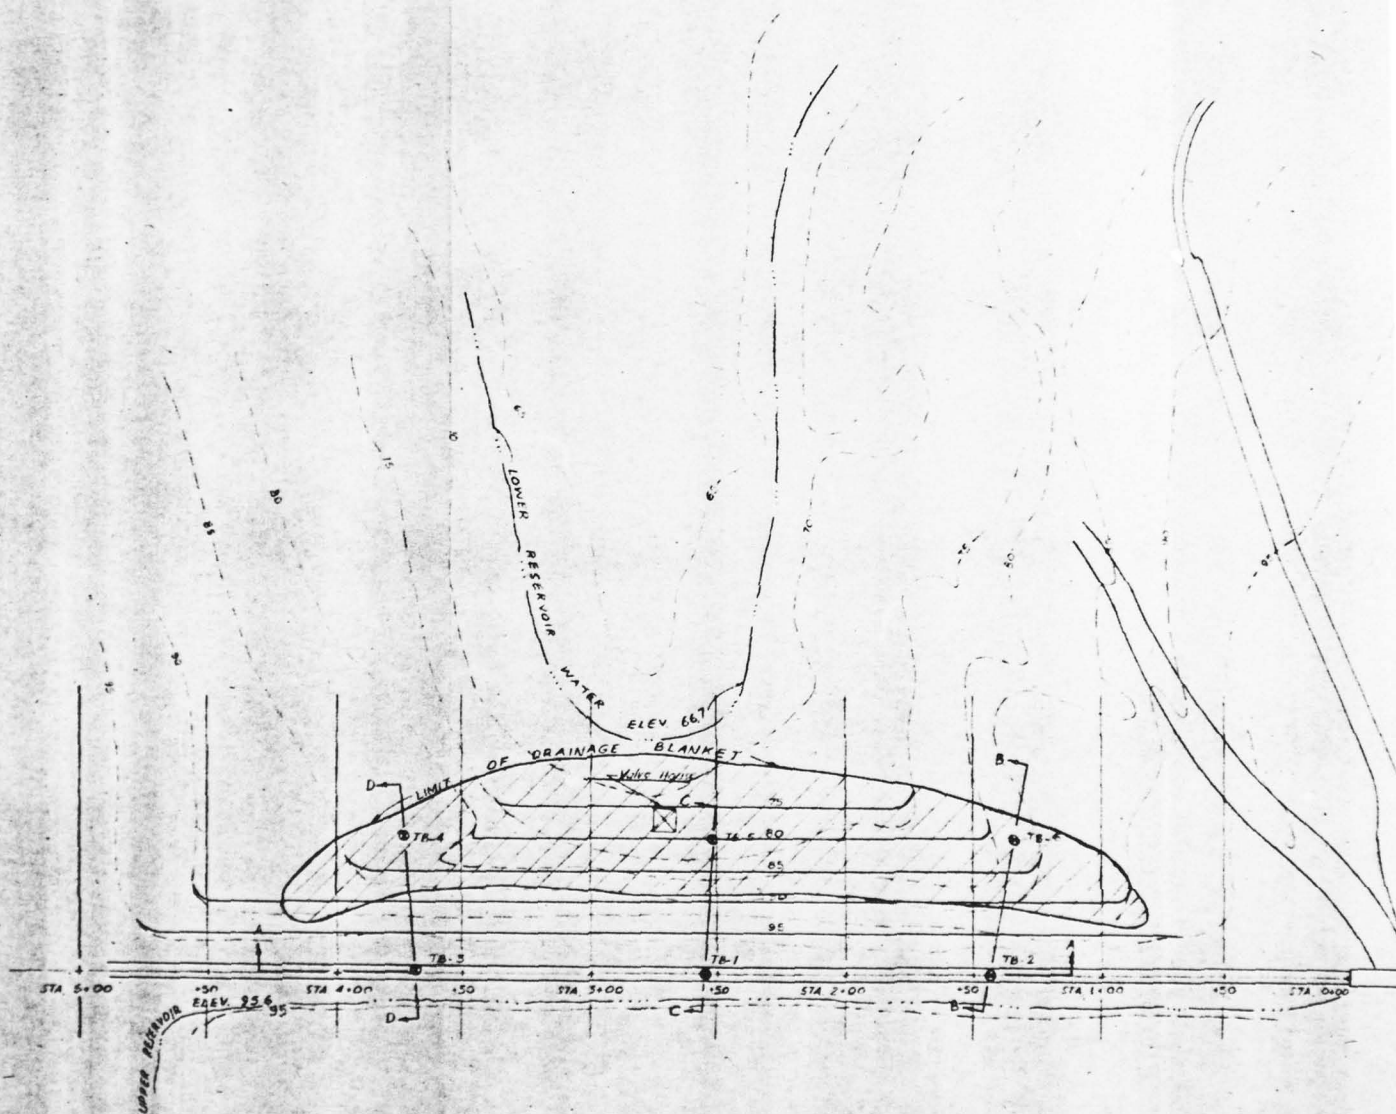
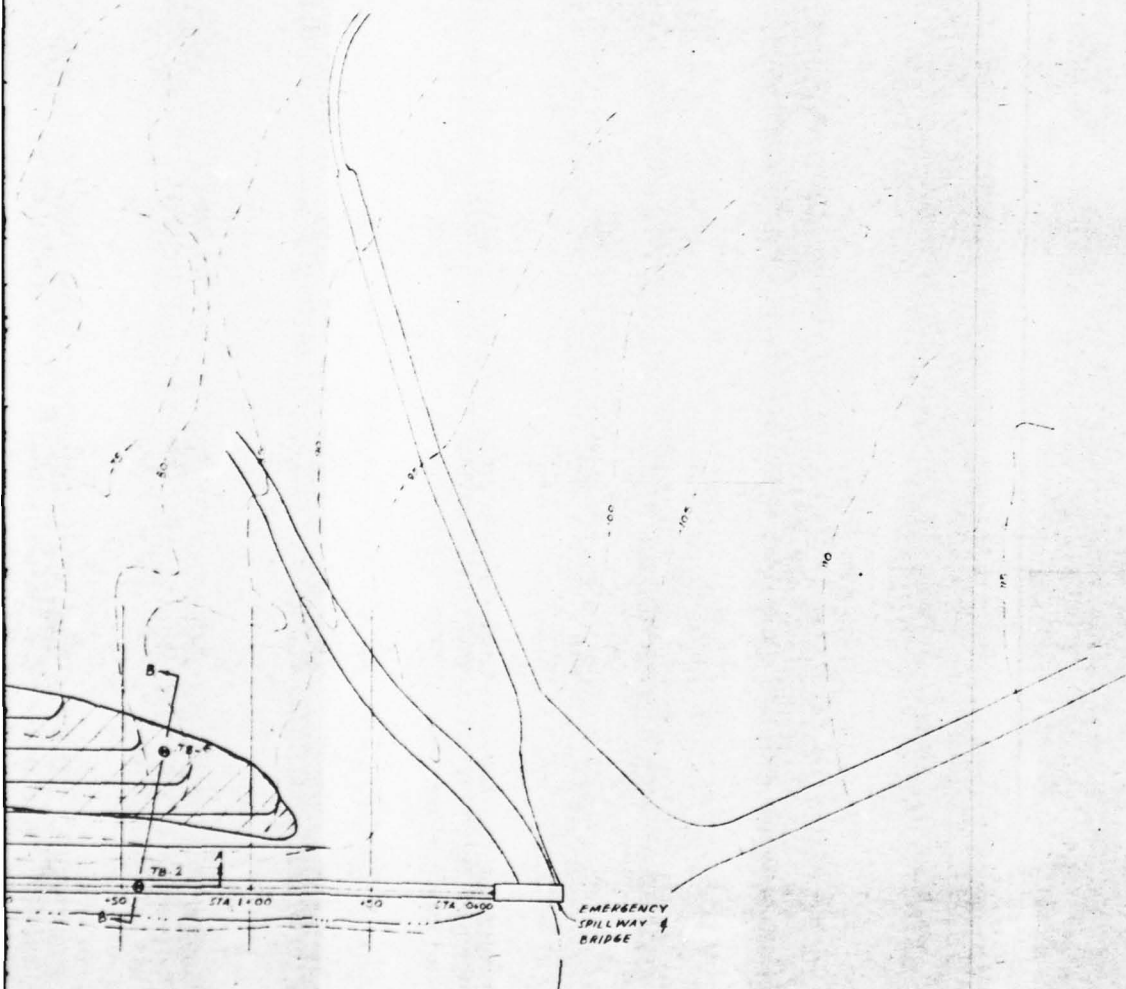
FIGURE 3

2. Embankment. In 1978, six test borings were drilled along the downstream side of the embankment by the owner's consultant for the purpose of assessing the existing conditions within the embankment and to develop design parameters for the proposed rehabilitation (see Figure 3). Three of the test borings were drilled through the embankment and all six borings penetrated at least 25 feet into the underlying bedrock to determine the type, depth, and engineering properties of these materials. Shelby tube and bag samples were secured for subsequent direct shear and permeability tests and for laboratory compaction, permeability and classification tests, respectively. Soil and rock field permeability tests were performed in four of the test borings. Typical embankment cross-sections depicting existing conditions within the embankment are presented on Figure 4, Appendix F. The methods and results of the testing are presented in the consultants report.

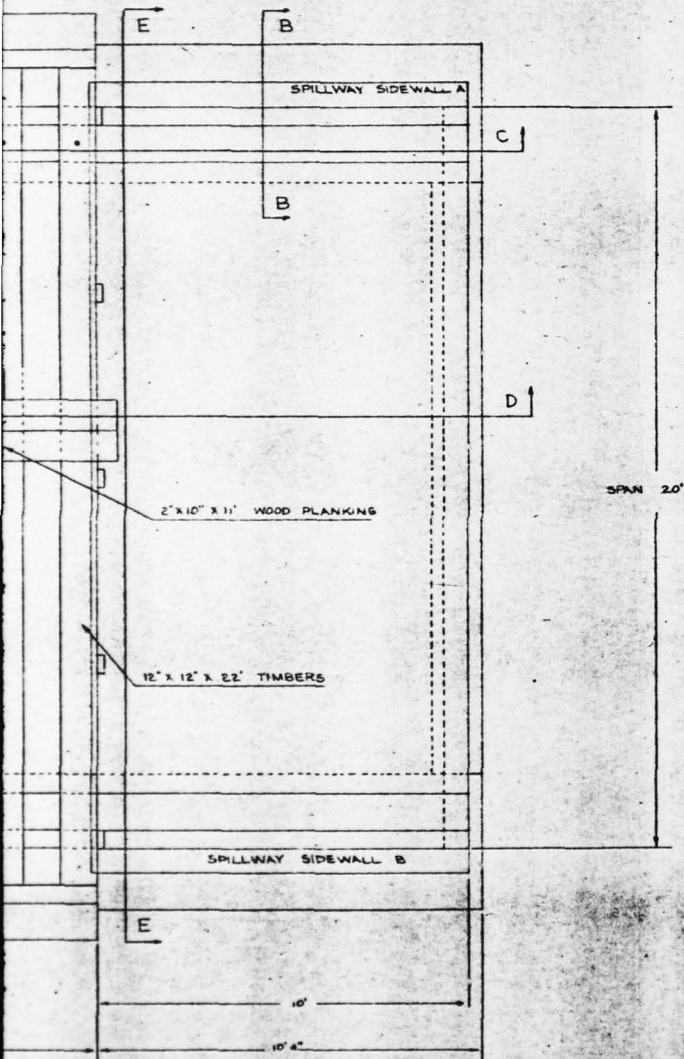
FIGURE 5

c) Spillway. The spillway consists of a recently constructed reinforced concrete chute and an unlined discharge channel (see Figures 5 and 6). At the control section, the concrete channel is approximately 20 feet wide and 36 feet long. Discharge from the spillway enters a channel cut in natural ground and flows into the reservoir of Twin Lakes No. 1 Dam approximately 250 feet downstream of the Upper Donohoe Dam.
